COVERED BRIDGE STUDY

WARREN BRIDGE

BRIDGE NO. 06
FAS HIGHWAY 188

MAY 1995

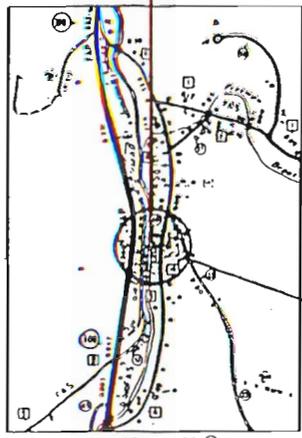
WARREN, INSET ①
SCALE 1:50,000

BRIDGE SITE

Figures 2 and 3 depict the location of the Warren Bridge in the central portion of the Town of Warren. Figures 4 and 5 present general photographs of the structure and both approaches.

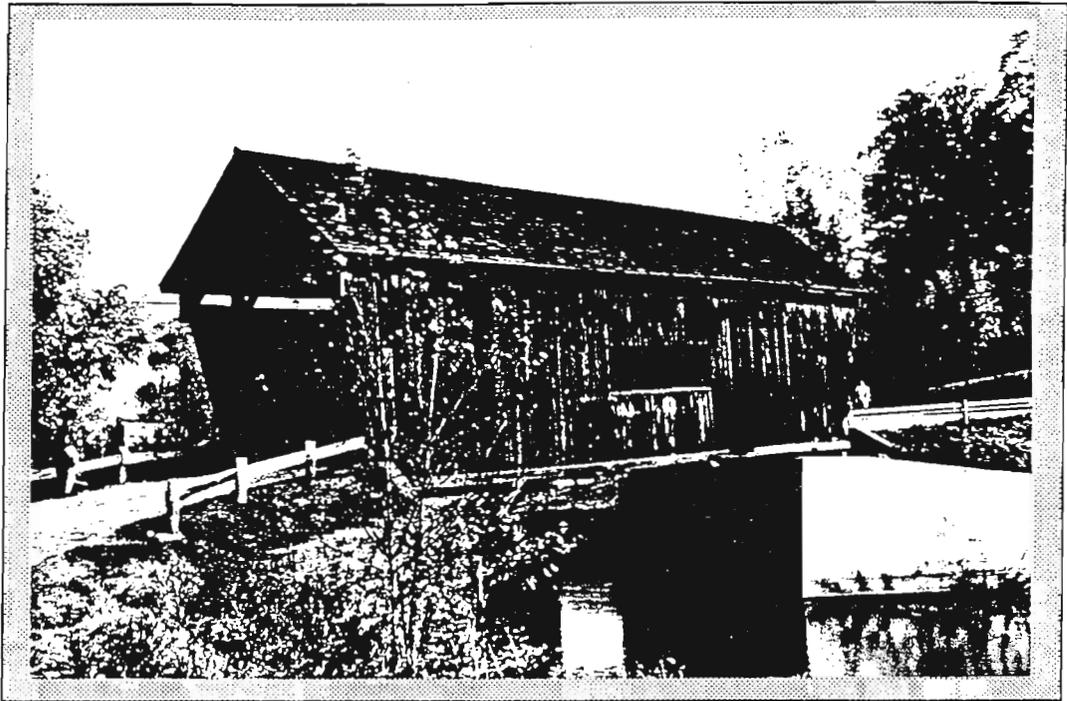
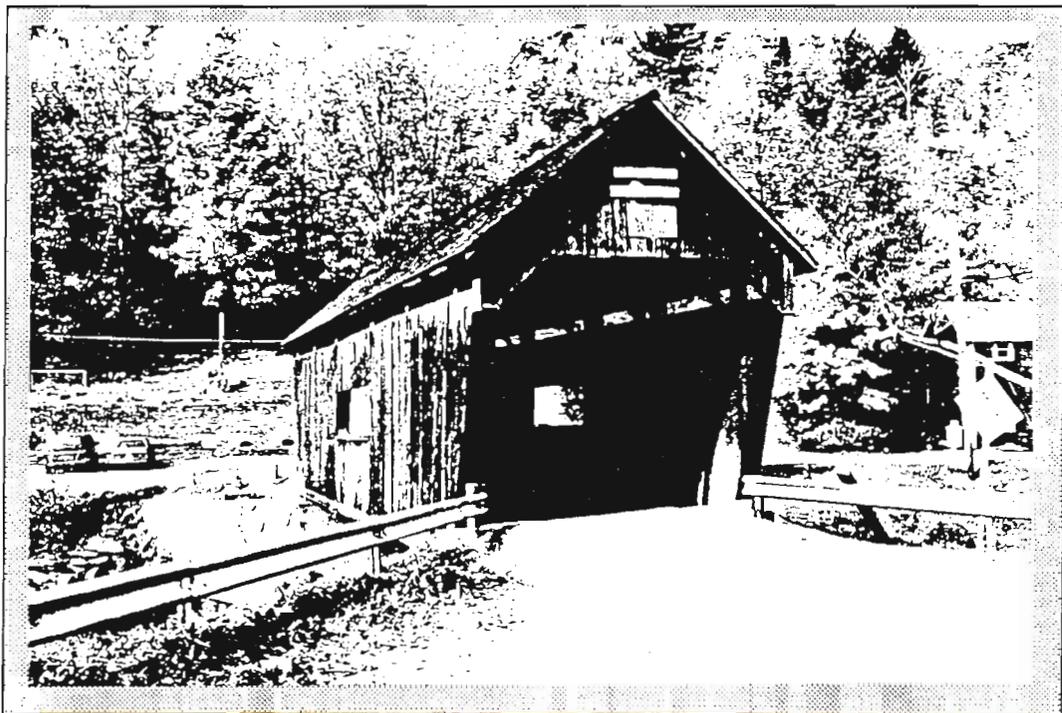
FIGURE 4

ELEVATION VIEW

END VIEW

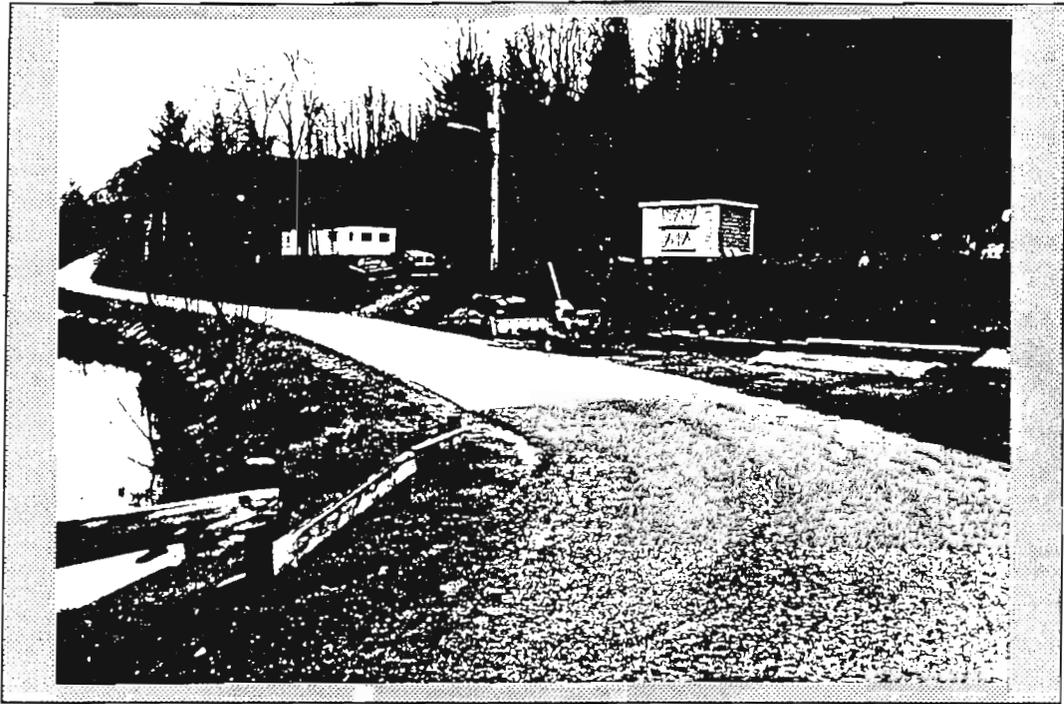
FIGURE 5

VIEW LOOKING WEST

VIEW LOOKING EAST

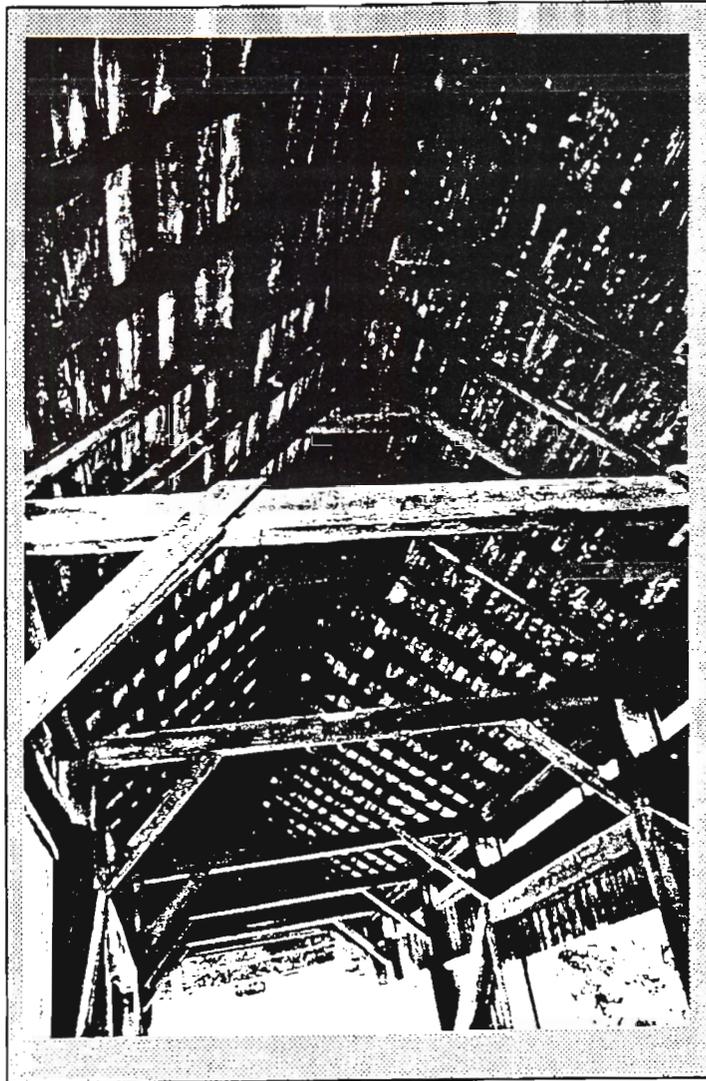
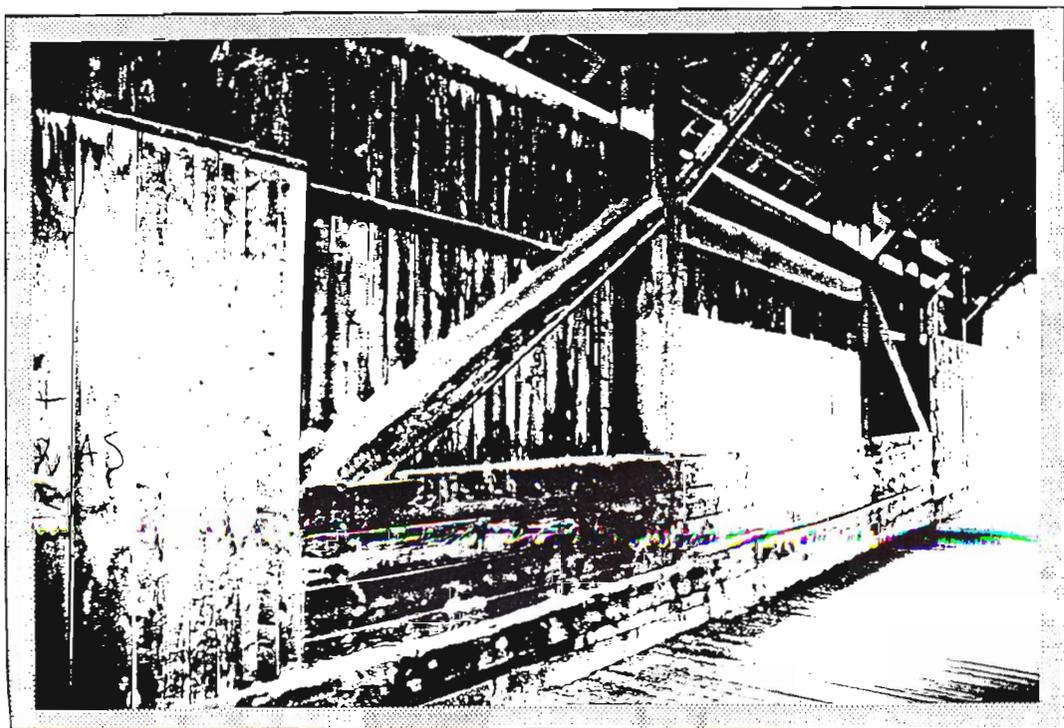
FIGURE 7

ROOF FRAMING

QUEENPOST TRUSS

Timber Truss Configuration	Queenpost
Number of Spans	1
Measured Length (End to End)	54.9'
Gable Overhang (Each End)	4'-5"
Measured Horizontal Clearance	13.33'
Measured Vertical Clearance at Truss	10.17'
Measured Vertical Clearance at Center of Bridge	12.75'
Sidewalk Provided	None
Approach Roadway Surface	Asphalt
Load Posting	Missing
